*Dredging Operations Technical Support Program*

# **Characterization of Suspended Sediment Plumes Resulting from Barge Decanting in San Francisco Bay**

June 2015

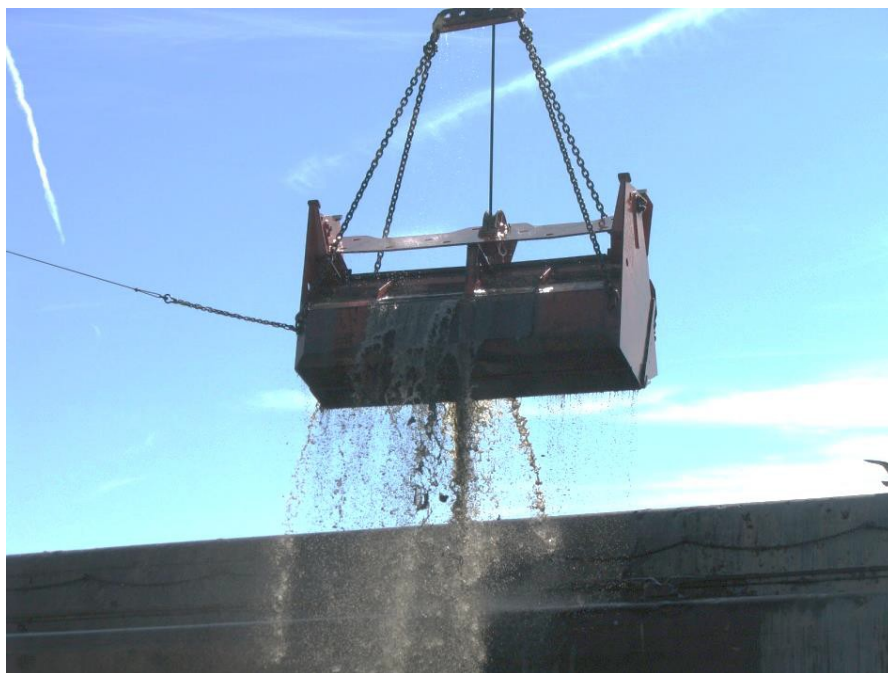
Figure 2. Fourteen cyd closed environmental bucket used by the Dredge *DB Palomor* in the Port of Richmond.

Dredging was conducted by the *DB Palomor* using a 14-cubic yard closed environmental Cable Arm® bucket (Figure 2) operated by RES Engineering, Inc. The dredge has a 75-ton capacity crane with barge dimensions of 150' x 54' x 13'. For position maneuvering, it has the capability of using two 80' spuds or four anchors and buoys. The latter anchoring technique was used during the present study.

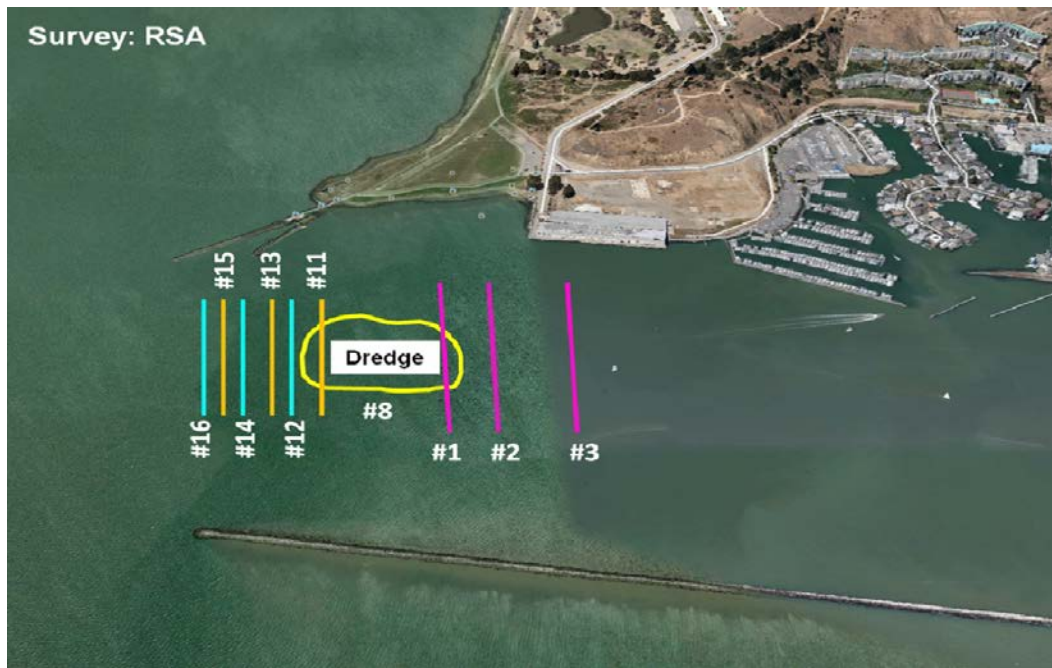
Figure 4. Layout of transects for Survey RSA.

Data collection during an ebbing tide occurred on 8 November 2012. Two surveys were completed. Survey RSA consisted of 10 transects. Transect RSA-8 encircled the dredging operation. Six transects covered a downstream portion of the study site progressing westward from the dredge towards Channel Marker R-6. Downstream extent of the survey was based on the observed decay of the plume in comparison with ambient conditions (Figure 4, RSA-11 through RSA-16). The first of these downstream transects (RSA-11) passed within 30 m of the point of bucket entry and exit from the water. The final transect in the series was occupied 298 m down-current of the dredging operation. Note that transects RSA-1 through RSA-3 were discussed in the above paragraph under the heading “Ambient Survey.” A plan-view layout of transects is depicted in Figure 4. Transect length ranged from 51 to 119 m (mean = 70 m).
